### Road Safety Audit of a Typical Multilane Rural Principal Arterial in Nigeria

**\*Adeleke, O.O., Jimoh, S.B., Akinola, O. and Sijuwola, O.O.**

Department of Civil Engineering, Faculty of Engineering & Technology, University of Ilorin, Ilorin, Nigeria

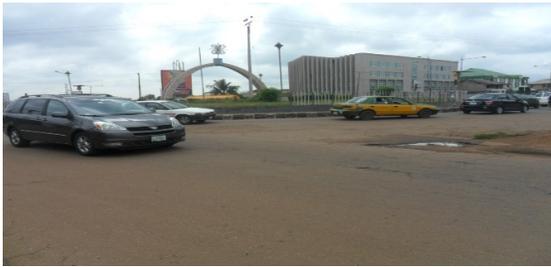
Plate 1: Start station of the audit route at km 0+000  
(Geri-Alimi Roundabout)

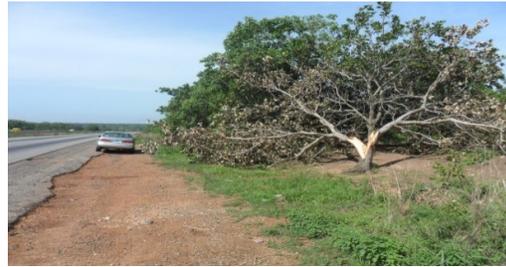
The start station of the road is seen in Plate 1. There are a lot of trees of varying sizes and types on both sides of the roadside within the safety zone. Some of the trees have diameters greater than one metre. During the field survey, trees which can be considered as fixed objects within the safety zone and which pose as high potential safety risks were recorded as shown in Plate 2. The trees are located at km 16+300, km 31+600 (Ilorin – Ogbomosho direction) and km 22+300 (Ogbomosho – Ilorin direction).

Plate 2: Trees within the safety zone at km 16+300

In order to enhance lateral sight distance, the trees must be removed from the safety zone. However, the potential benefits of removing such obstacles should be weighed against the adverse environmental and aesthetic effects of their removal. Therefore, trees should be removed only when considered essential for safety and alternatively, trees which cannot be removed should be protected by guardrails.

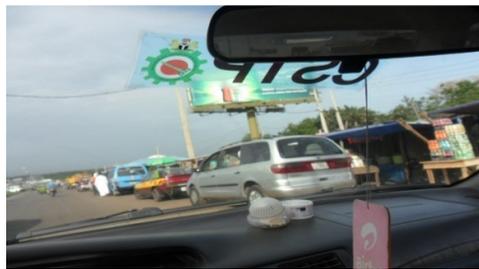
There is the improper location of an unauthorized motor park/garage on the shoulders of the audited route at km 0+300 to km 0+650 as shown in Plate 3. The garage decreased the capacity of the roadway, which is very dangerous for road users and can cause accidents.

Plate 3: Improper garage location at km 0+300 to 0+650

The appropriate authority should relocate the garage from the roadside to a better place, not near the road.

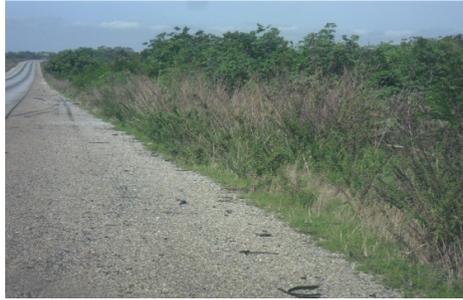
Plate 4: Missing safety zone with grass at shoulder edge at km 13+100

- Removal or relocation of objects, utility poles and other features from the safety zone area, or by burying the cables underground, this will be a long-term project with high cost implications.
- Installing reflectors on objects such as poles. that can be seen by drivers from a far distance. This solution has a low-cost implication and can be implemented within a short period.

- Installing guardrail or crash cushion for hazardous utility poles which has a low/mid cost implication for implementation near turns.
- Following the AASTHO standard by dedicating about 9 metres distance width for safety zone area.

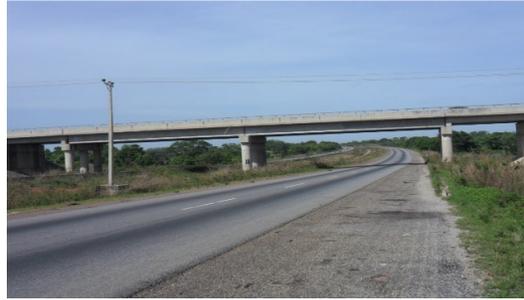
Plate 5: Utility poles within safety zone at km 11+700

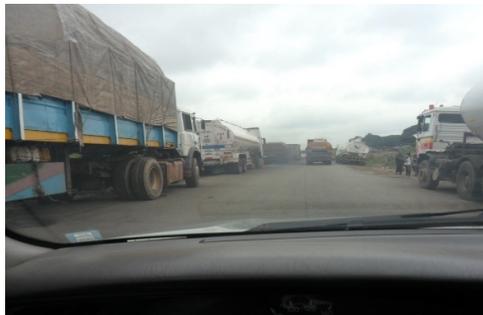
Trailers double parked on both sides of the road at km 34+300, Abule – Igbon town and have indeed turned the shoulders on both directions of the road to parks as shown in Plate 6. This is very dangerous and is an abuse of the road. The trailer drivers park recklessly without road/traffic management agency personnel to apprehend or correct them. Another dangerous aspect in this area is that the trailer drivers enter the carriageway from their parked locations anytime they want, without considering oncoming vehicles. Prolonged parking of heavy axle-load also weakens the pavement and shoulders.

Plate 6: Double parking on the roadway at km 34+300

‘No parking’ order should be enforced along the entire stretch of the road except in the case of emergency.

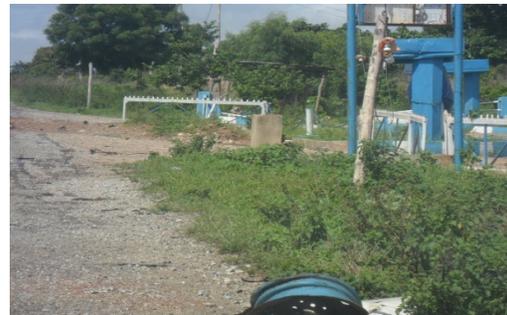
Plate 7: Improper access management at a filling at km 35+900

There are many petrol filling stations on both sides of the route, and almost all the filling stations were observed to be improperly designed to access the expressway. An example is shown in Plate 7. There is a particular filling station at km 35+900 between Abule – Igbon and Egbeda, where the entrance and exit of the filling station are within 4 metres of the road. Some drivers exiting from the filling stations may not clearly see oncoming high-speed vehicles which can result in a vehicle collision. Moreover, there were

grasses growing around the filling station which could also obstruct the view of drivers entering or exiting the petrol station.

Driveways to the entrances of the petrol filling stations along the study route should be re-designed to conform with specifications of the Federal Ministry of Works (2013) with appropriate road signs rightly placed to eliminate hazard risks. Grasses in petrol stations' premises resulting in reduced sight distances should also be removed.

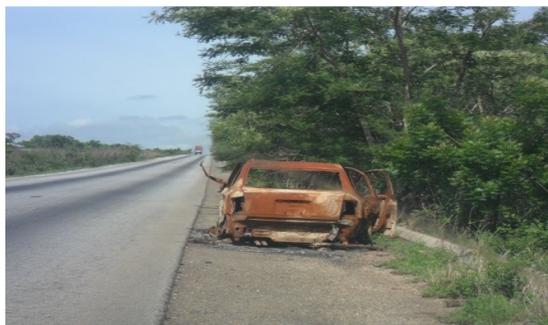
Accident vehicles were left at the accident scenes or on the shoulders of both sides of studied route uncatered for, which become safety risks. Abandoned accident vehicles were noticed at km 5+200, km 30+200 and km 43+100 (Ilorin – Ogbomosho direction) and also at km 17+800 (Ogbomosho – Ilorin direction). An example of such abandoned vehicles is shown in Plate 8.

Plate 8: Abandoned accident vehicle at km 30+200

There should be an arrangement by supervision road agency for quick removal of broken down and accident vehicles by stationing towing vehicles at strategic locations along the road. Drivers should also be enforced to use C-caution sign anytime vehicles break down on the road in other to alert other road users.

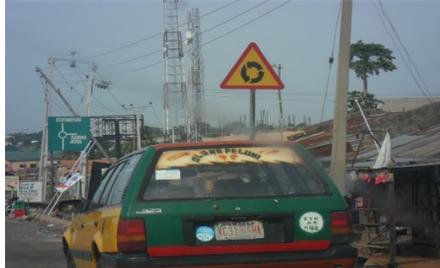
Most of the information signs were inappropriately located. At km 8+800 (Eiyekorin) when approaching the roundabout as shown in Plate 9 and likewise when approaching the T- junction in Ogbomosho, sighting of placed road signs is obscured by poles, billboards and vegetation that obstruct their clear view and their placements are too close to the intersections, which does not permit drivers to be alerted early before reaching the intersection. The road signage at Ogbomosho T – junction is overgrown with vegetation as evidenced in Plate 10. It was also observed that all the markings on both sides of the route were completely worn out to the extent that they are hardly visible. As a result of these, drivers are not well guided on the lanes which might be a contributory factor to accidents along the route.

Plate 9: Improper signage at km 8+800

- Worn out signs should be replaced with new ones.

- Signage should be properly located and installed at required sections of the route (e.g. approaching bridges, intersections, dangerous curves, work zones, schools etc).
- There should be very visible road markings where necessary, such as Left-turn, Right-turn, U-turn, pedestrian crossing signs etc.
- Existing markings/road signs improperly located and which can cause confusion on the route should be relocated.

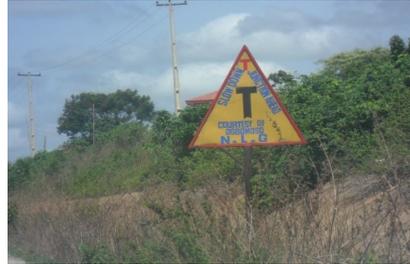
Plate 10: Signage almost covered by vegetation at km 49+300

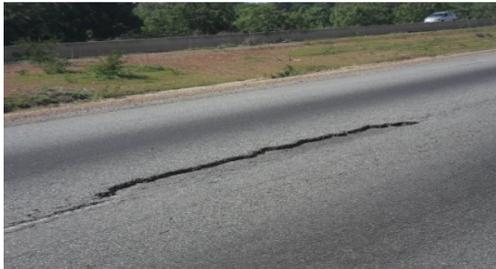
Plate 11: Pavement defect (slippage cracks) at km 12+100

- The missing shoulder should be reconstructed and paved.
- Filling the potholes with appropriate materials where necessary should be done.
- The appropriate authorities should check and maintain the route and quickly fix any defects on the route for better and safer movements.

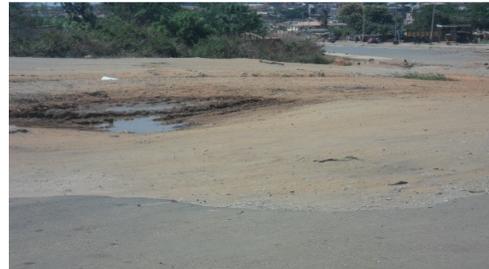
Plate 12: Pavement defect (asphalt removed) at km 50+100 (both sides of the road)

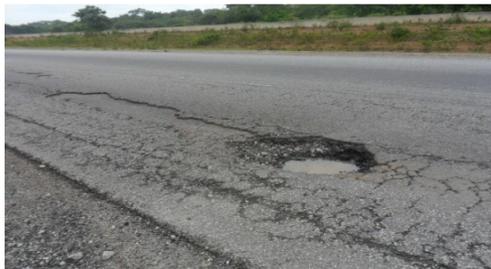
Plate 13: Pavement defect (pothole) at km 17+500

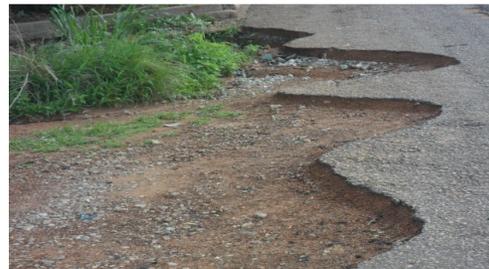
Plate 12: Wearing of the shoulder at km 5+200

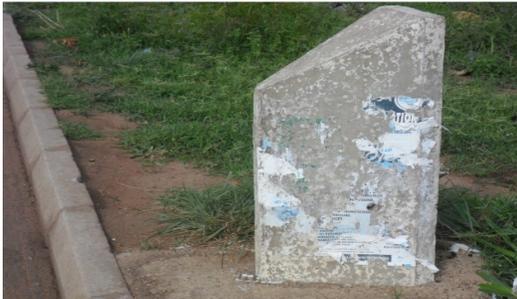
Plate 13: Obliterated kilometre post at km 1+300

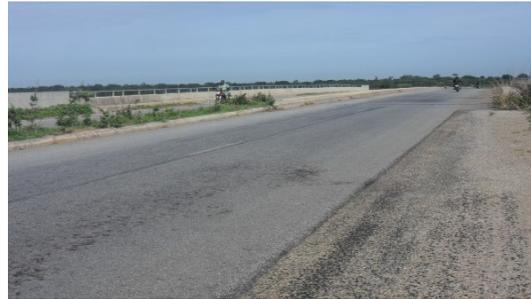
Plate 14: No signage on either side when approaching the bridge at km 37+700

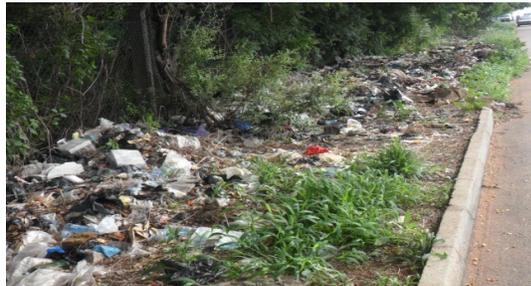
Plate 16: Dumping of garbage's at km 4+500

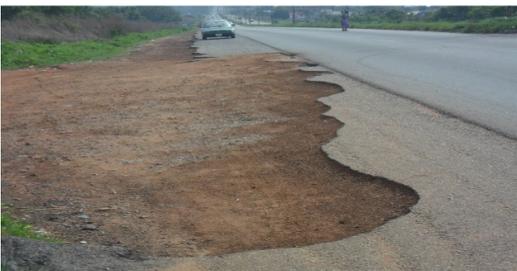
Plate 17: Road edge breaks at km 8+100

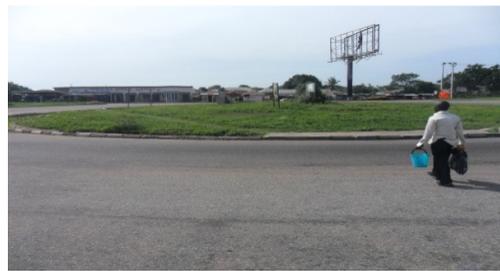
Plate 18: No pedestrian crossing signage or footbridge throughout the road length

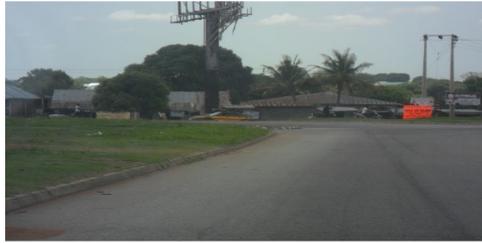
Plate 19: Buildings on the safety zone on both side
