Operational Status of Water Borehole Schemes in South-Eastern Nigeria

*¹Ibeje, A.O. and ²Nwachukwu, M.C.

¹Department of Civil Engineering, Imo State University, Owerri, Nigeria.

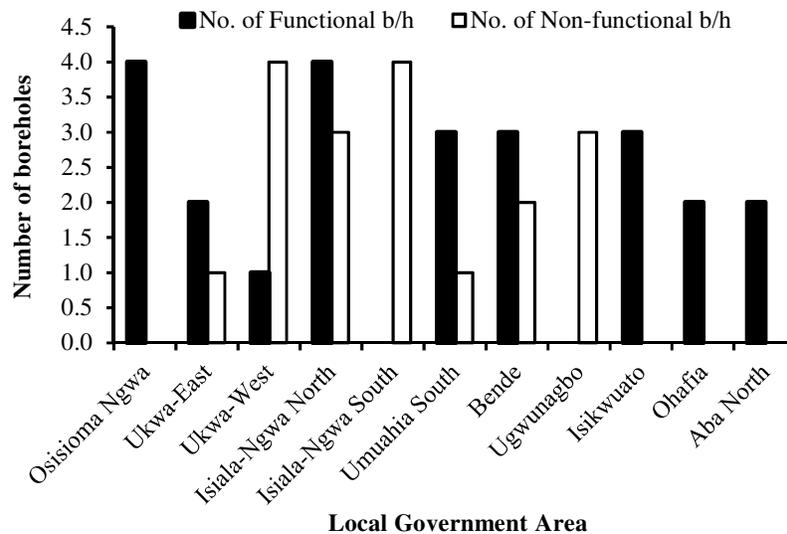
Figure 2: Status of water boreholes in Abia State

In Abia State, the number of dysfunctional boreholes amounted to 18 of the total 42 boreholes in February 2017 as depicted in Figure 2.

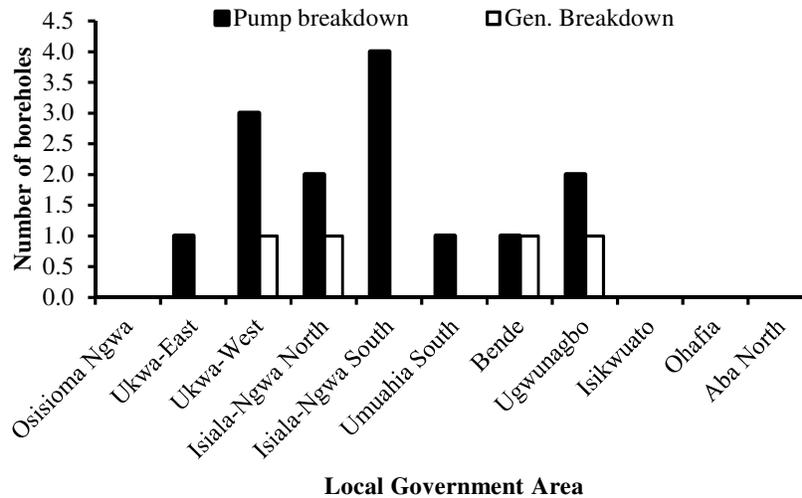
Figure 3: Status of faulty borehole component in Abia State

Figure 3 shows that 14 of the dysfunctional boreholes in Abia state were not functional due to pump problems, while 4 boreholes were dysfunctional due to generator breakdown.

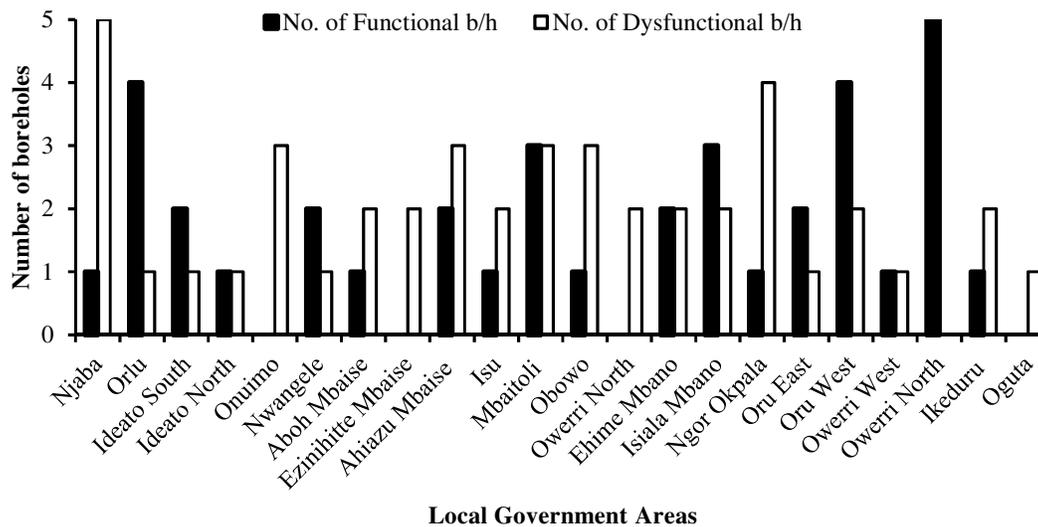
Figure 4: Status of Water Boreholes in Imo State

For Imo State, 44 boreholes out of a total of 81 were dysfunctional as shown in Figure 4. Figure 5 indicates that of the 31 boreholes were not functional due to pump problems, while 13 were dysfunctional due to generator breakdown.

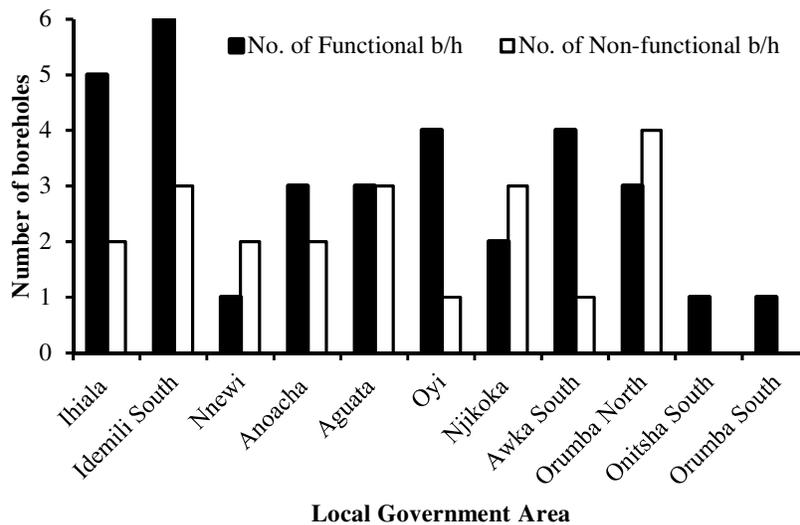
Figure 6: Status of water boreholes in Anambra State

In Anambra, the number of dysfunctional boreholes was 21 boreholes out of a total of 54 as shown in Figure 6. Figure 7 indicates 11 boreholes were not functional due to pump problems, while 10 were dysfunctional due to generator breakdown.

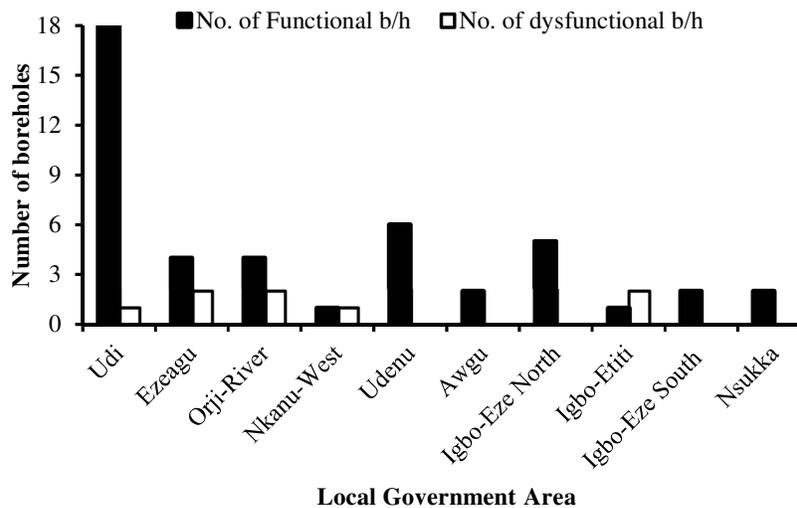
Figure 8: Status of water boreholes in Enugu State

The number of non-operational boreholes in Enugu State amounted to 8 boreholes out of a total of 53 as depicted in Figure 8. Figure 9 indicates that 5 boreholes were not functional due to pump problems.
