Geophysical Investigation of an Earth Dam: A Case Study of Agba Dam, Ilorin Southwestern Nigeria

Geophysical investigation of Agba dam, Ilorin, Southwestern Nigeria was undertaken to assess the vulnerability of the dam to seepage. The field survey involved very low frequency electromagnetic (VLF-EM) and vertical electrical sounding (VES) techniques with Schlumberger electrode configuration. VLF-EM survey at 10 m and 20 m spacing were conducted along the axis and flanks. Forty VES were carried out on four traverses established in NW–SE direction along the dam axis and NE–SW directions along the right and left flanks. Results of VLF-EM showed conductive zones indicating possible fractured basement. VES data revealed three to four geo-electric layers; topsoil, having resistivity range of 149–1282 Ω m with a mean of 448 ± 315 Ω m, thickness of 0.4–4.2 m with a mean of 2.0 ± 0.8 m, lateritic hardpan with resistivity of 924–1614 Ω m and a mean of 1235 ± 269 Ω m, layer thickness of 1.6–3.2 m with a mean of 2.3 ± 0.5 m, weathered and fractured basement with a resistivity of 12–115 Ω m with a mean of 51 ± 29 Ω m, thickness of 2.5–21.2 m with a mean of 9.4 ± 4.9 m. Fresh basement had a resi

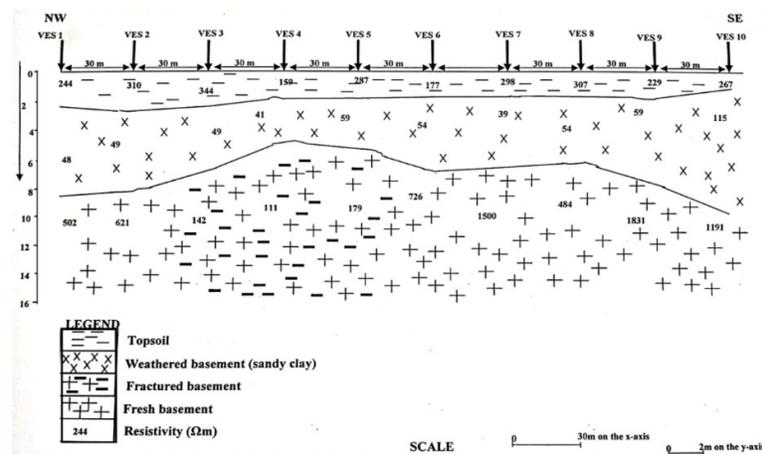
The VES data obtained revealed three to four geo-electric layers comprising topsoil, lateritic hardpan, weathered basement (sandy clay) and the fractured/fresh basement rock (Figures 2a-2d). The topsoil resistivity ranged from 149–1282 Ωm with a mean of $448 \pm 315 \Omega\text{m}$ and thickness varying from 0.4–4.2 m with a mean of $2.0 \pm 0.8 \text{ m}$. Lateritic hardpan had high resistivity ranging from 924–1614 Ωm with a mean of $1235 \pm 269 \Omega\text{m}$. The range of the layer thickness was from 1–3.2 m with a mean of $2.3 \pm 0.5 \text{ m}$. The weathered basement (sandy clay) had resistivity ranging from 12–115 Ωm with a mean of $51 \pm 29 \Omega\text{m}$ and thickness varying from 2.5–21.2 m with a mean of $9.4 \pm 4.9 \text{ m}$. The basement rock had resistivity ranging from 111–1831 Ωm with a mean of $643 \pm 380 \Omega\text{m}$. Possible fractured basement occur in areas with resistivity $<400 \Omega\text{m}$ while areas having resistivity $>400 \Omega\text{m}$ indicates fresh basement rock. Depth to bedrock ranged from 4.3–14.6 m along the dam axis, 4.1–21.2 m along the left flank and 4.9–14.6 m along the right flank.

Low resistivity and the presence of conductive zones within the basement revealed by the VES and VLF-EM are indications of possible fractures which are usually caused by seepage. This fractured basement occurs in areas with resistivity $<400 \Omega\text{m}$ while areas having resistivity $>400 \Omega\text{m}$ indicates fresh basement rock. The presence of these fracture zones can greatly reduce the reservoir capacity of the dam. Seepage in dam body in most cases at the dam foundation can lead to the formation of reed erosion which can eventually result in landslide and possible collapse of a dam.

Figure 2a: Geo-electric cross-section along the dam axis

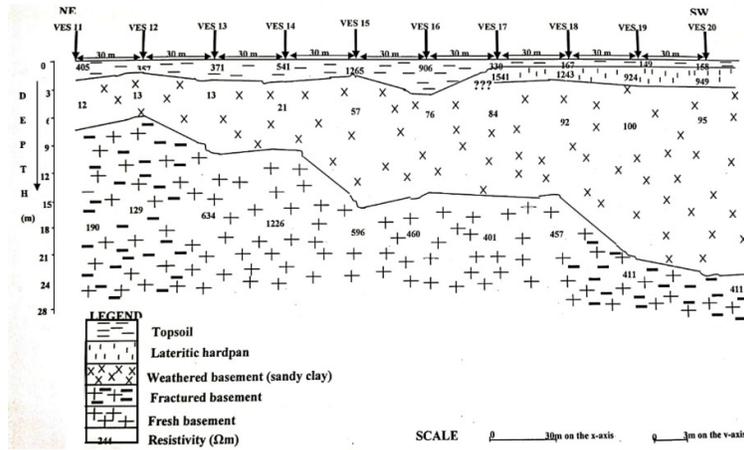
Figure 2b: Geo-electric cross-section 1 along the left flank

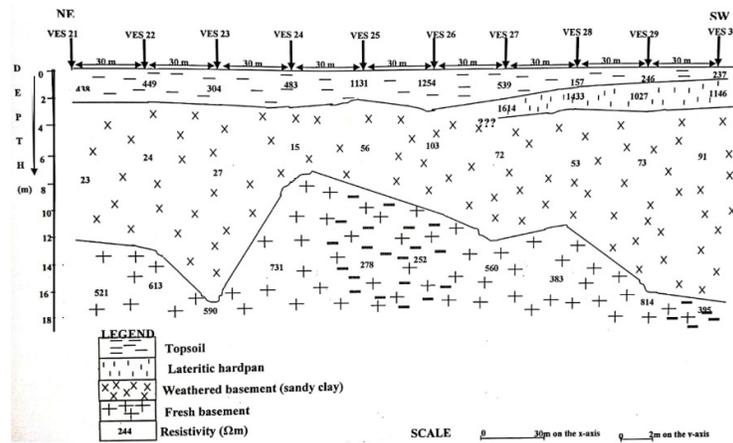
Figure 2c: Geo-electric cross-section 2 along the left flank

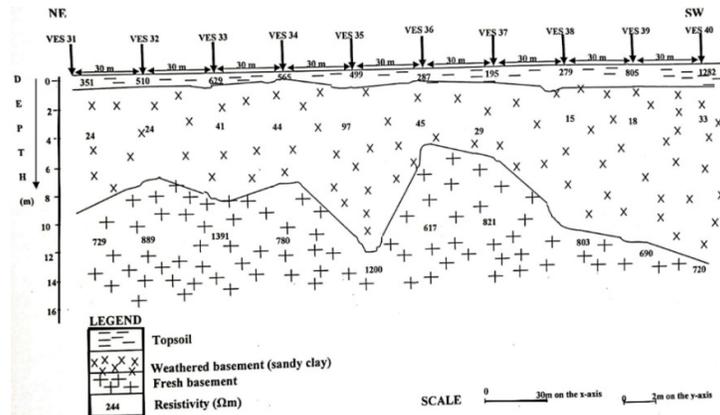
Figure 2d: Geo-electric cross-section along the right flank

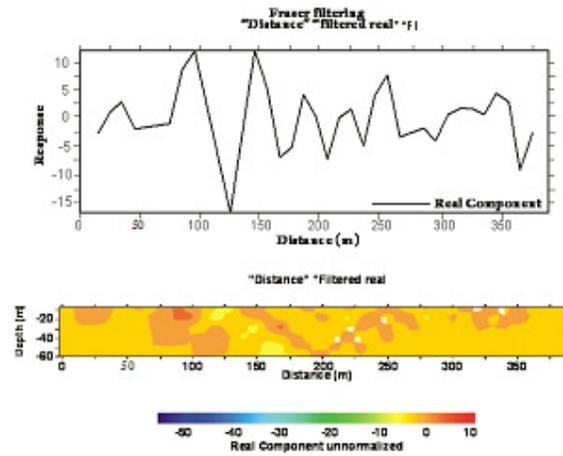
The results of VLF-EM survey along the dam axis, the left and right flanks show conductive zones indicating possible fractured basement. The plot of filtered real against station distances is shown as profile as presented in (Figures 3a-3f). Conductive targets are denoted with positive Fraser and Karous-Hjelt filtered anomalies. Red color is suggestive of presence of conductive (weak) zones. Such points were identified on the profiles.

Figure 3a: VLF profile for dam axis at 10 m spacing and corresponding KH section

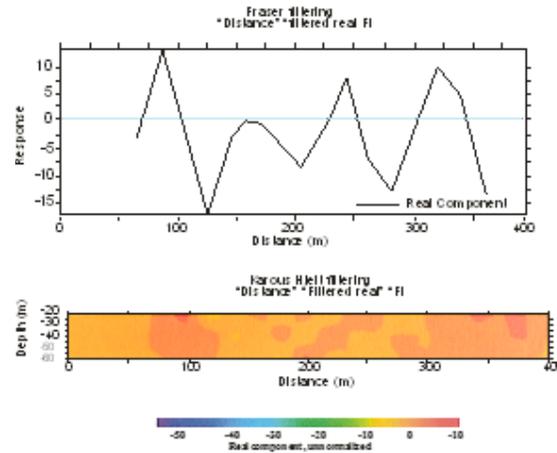
Figure 3b: VLF profile for dam axis at 20 m spacing and corresponding KH section

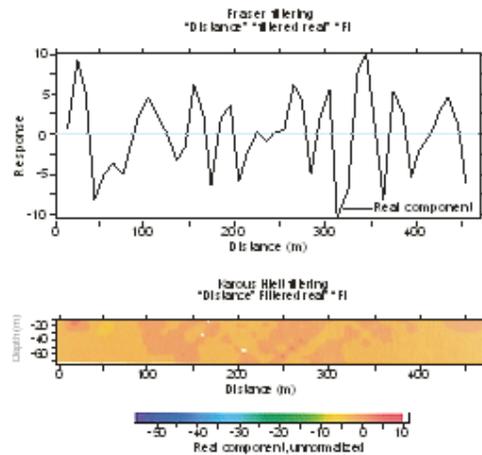
Figure 3c: VLF profile for left flank at 10 m spacing and corresponding KH section

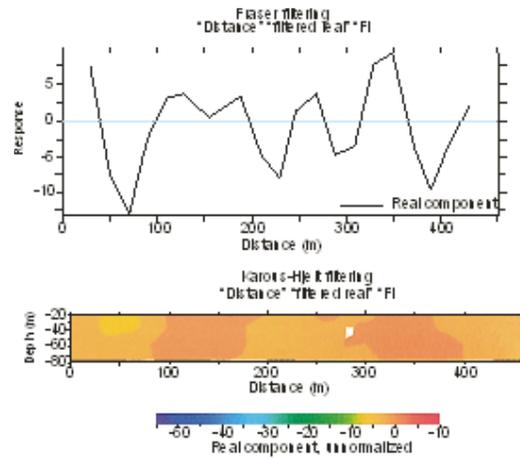
Figure 3d: VLF profile for left flank at 20 m spacing and corresponding KH section

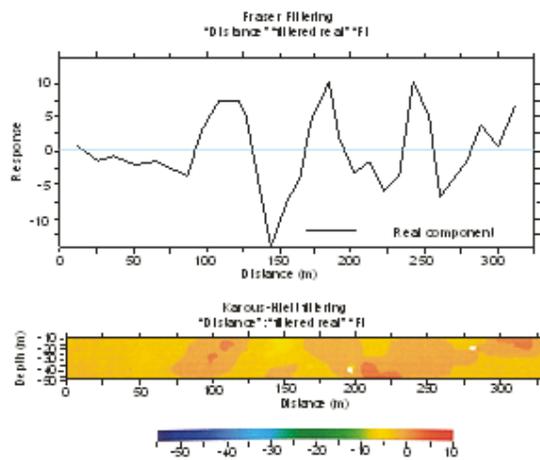
Figure 3e: VLF profile for right flank at 10 m spacing and corresponding KH section

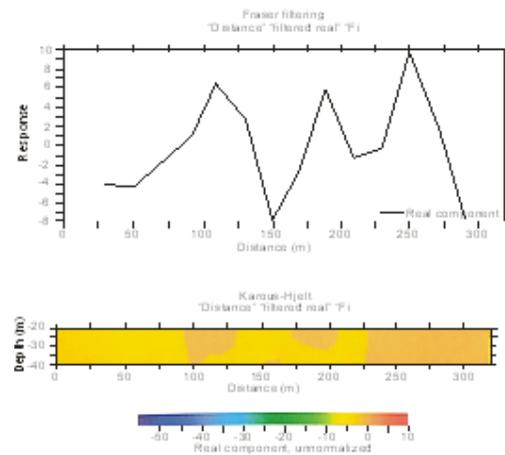
Figure 3f: VLF profile for dam axis at 10 m spacing and corresponding KH section
